PROJECT 5: RESERVOIR – KAMPING PUOY RESERVOIR AND CATCHMENT, CAMBODIA

1. Project Overview

1.1. Site description

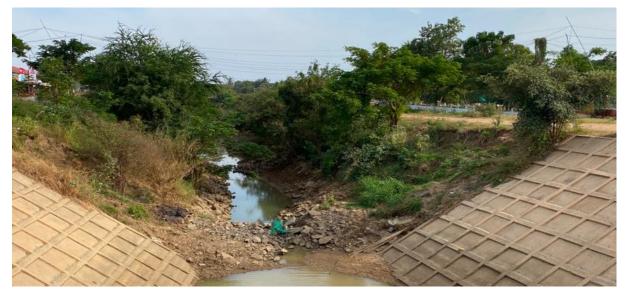
Figure 2: Canal downstream of the diversion near regulated gate

Figure 2 shows the canal 800 m downstream of the diversion close to a regulated gate, which controls the flow in the canal. The estimated geometry is 6m depth, 3 to 4 m at the bottom and maximum of 24 m width at the top.

With the estimated canal geometry and an assumption of 3 m water depth in the canal, the total volume along the 15 km is approximately 400 000 m³, which is already a considerable water storage.

With 3 m water depth, the total water surface would be approximately $200\ 000\ m^2$. With a daily potential evaporation of 5 mm based on a rather conservative calculation, the daily loss would be approximately $1000\ m^3$ if the water depth in the canal was 3 m.

The weekly losses would be 7000 m³ and monthly losses roughly 30 000 m³. The total loss from evaporation due to operating this canal could be as much as 360,000 m³ every year depending on the number of days when the canal is filled. Seepage is not counted as losses as the water percolates into the groundwater and is therefore not lost. From an operational point of view, reducing the number of days of operation and if in operation conveying a maximum amount of water seems advantageous to minimise losses. However, there is a disadvantage with such a release policy. The maximum amount of water means high flow velocity and thus high shear stress for both the bed and the banks of the canal. Erosion and hence sediment load will increase and will finally end up in the reservoir. Since the banks of the canal are bare soil and given its length, erosion will be significant.

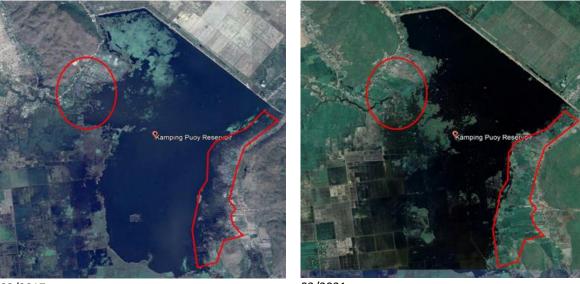
Figure 4: Land use encroachment over time at Kamping Puoy Reservoir

The field mission and remote sensing revealed that substantial encroachment of the reservoir area takes place during periods of low water levels. When the water level drops, the new land surface is encroached and used for agricultural purposes. The area of the reservoir has shrunk over time. In addition to a possible loss of storage, cultivating crops on areas which might be subject to flooding will transfer organic material, fertilizers and pesticides into the reservoir leading to increased oxygen consumption and eutrophication. The progress over time is illustrated in Figure 4.

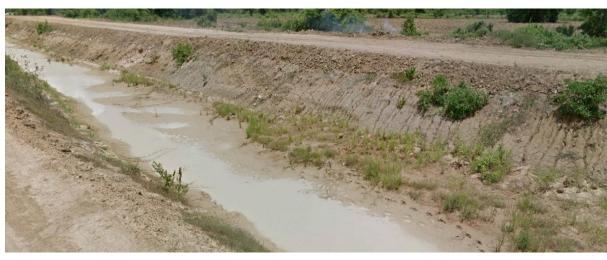
Figure 5: Signs of erosion of canal banks and sedimentation

Given the current design of the canal with unvegetated, eroded banks, it is bringing sediment into the reservoir. More effective management of the canal could help reduce erosion and safeguard the Kamping Puoy Reservoir.

The sediment from the canal settles in the reservoir and reduces its life span. This leads to a reduction in flood mitigation functions and decreases in drought resilience.

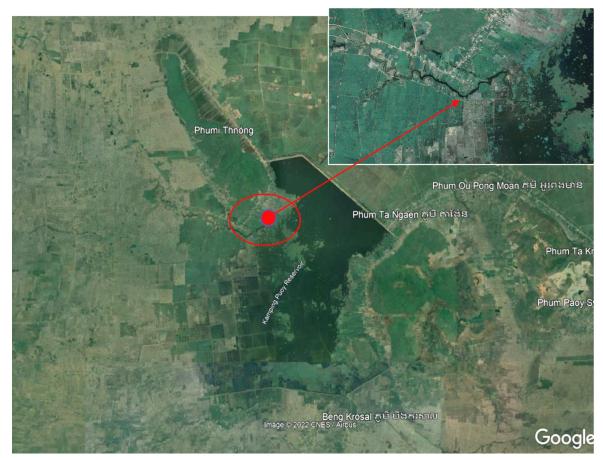
Figure 7: Potential sediment trap location

Sediment traps are proposed immediately upstream of the reservoir, near to the inflow channel. The establishment of small multiple functioning sediment traps/pools (through NbS and hybrid structures) offers significant potential within this landscape area. Such interventions would help to collect sediment before it enters the reservoir to prevent sedimentation and decreased water storage capacity.

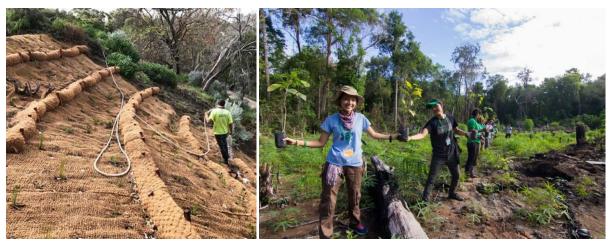
Figure 8: Example forest restoration, with NbS erosion control

Opportunities for forest restoration were identified on the steep elevated areas immediately to the east and west of the reservoir. Due to the elevation of these areas, they will require slope stabilisation NbS (see Figure 8 and Measure 6, Annex 1 for example measures).
