PROJECT 6: RESERVOIR – ANG TRAPEANG THMOR LAKE AND PROTECTED FOREST, CAMBODIA

1. Project Overview

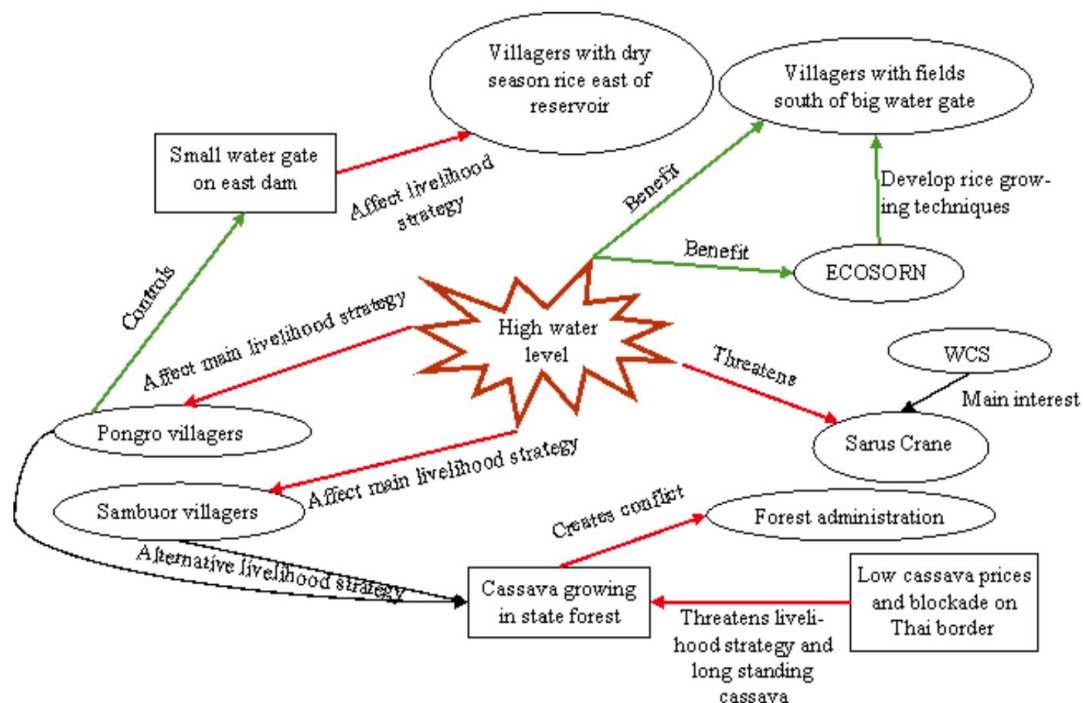
Figure 1: (top) historic water-related conflict at ATT; (bottom) location of villages in ATT area

Sediment management and watershed rehabilitation at ATT are the priority interventions for this landscape. Through consultation, it is understood that the main water management concern for ATT is water allocation between upstream and downstream stakeholders and communities, and the associated management of the reservoir gates. There has been historic conflict between the local villages adjacent to ATT, who have direct access to the reservoir, and other downstream villages who rely on water supplied from the reservoir, over the control of water resources including for irrigation purposes.

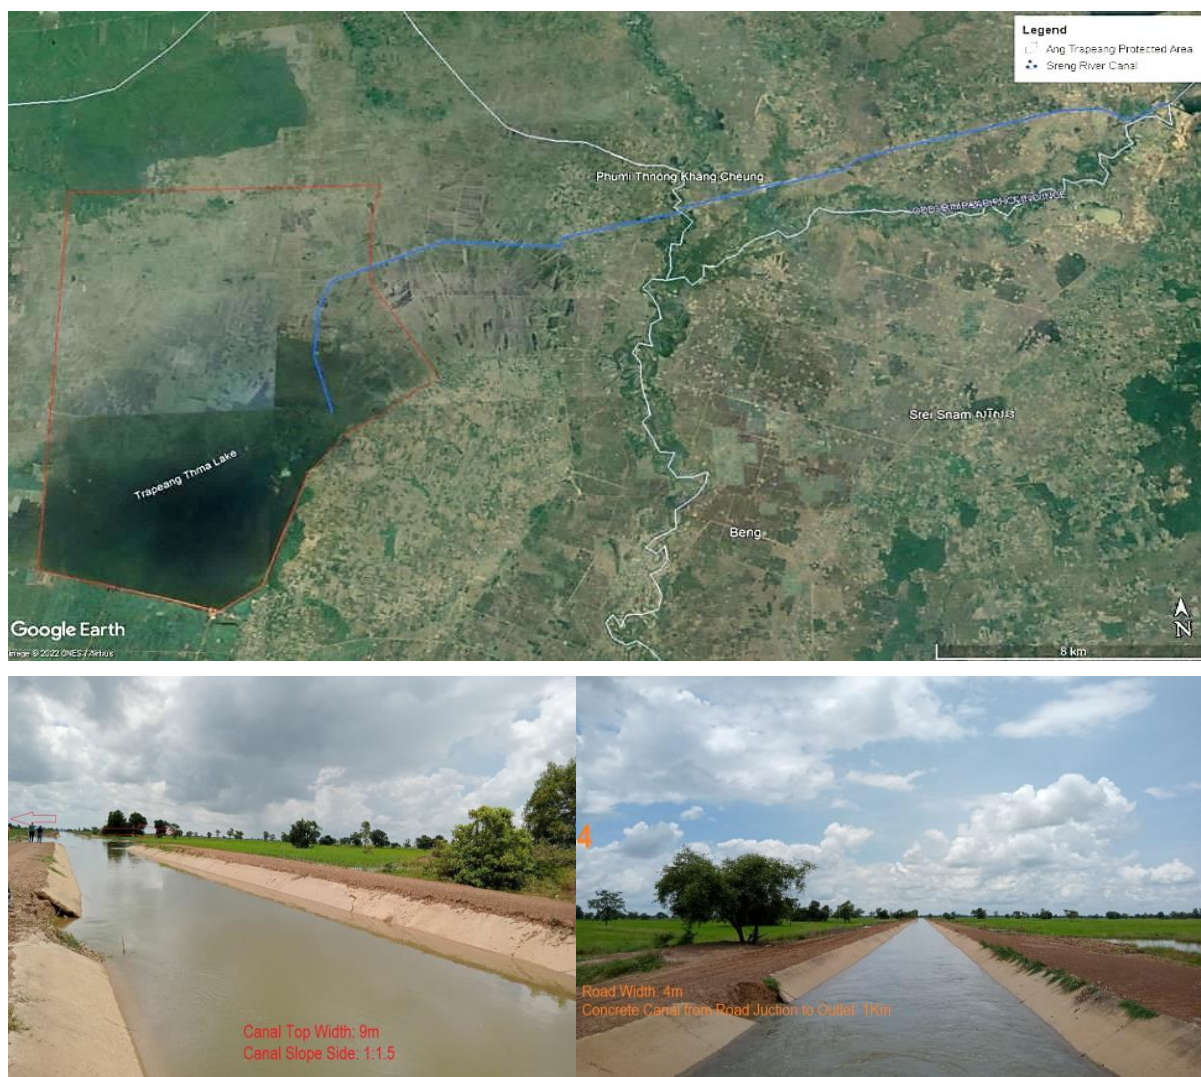
Figure 6: Sreng River canal diversion

The recently constructed 34km long Sreng canal diversion was constructed to support seasonal drought resilience (Figure 6). Cross-sections do not change significantly along the full length. A road network follows on both sides of the canal which is some 9 m in width, connected by bridges at regular intervals. The roads and concrete banks are along the entire length either side of the main waterway (sparsely vegetated in some areas). Adjacent land comprises largely agricultural land, presenting a challenge for extending a vegetated buffer further.

- (i) The 34km long Sreng canal diversion was recently constructed to support seasonal drought resilience (Figure 6). The canal is the main trunk to link the Sreng River with the ATT reservoir.

The Sreng canal inflow could present locations for possible NbS interventions, including the planning and design of riparian buffers and a natural canal and wetland system, with no dry season flow. Such interventions could be undertaken solely within the 9C-9T boundary area (approximately 10 km), even so a larger intervention would create more impact.

A vegetated strip either side of the canal is recommended at a width of a minimum of 15m wherever practicable, in line with good practice design (see Measure 1, Annex 1). The vegetative buffer strip should comprise a mix of native species to ensure buffer integrity. Community representatives explained that acacia trees have been planted extensively throughout the ATT landscape, along roads and fields, in order to harvest wood, create shade and reduce erosion. Concerns were raised about nutrients losses, including reduced rice yields next to the acacia trees. The community members suggested to introduce and plant the Neem tree (*Azadirachta indica*, khmer: sdaw) as a native and affordable alternative as potential buffer vegetation.
